**Flood Control Project Maintenance
Levee Inspections**
LMA District Cover Sheet
Spring 2019 Levee Inspection Results

Merced Streams Group

Spring 2019 Levee Inspection Results

Waterway			Bank	Unit Miles
Unit No. 01 Black Rascal Diversion			Right	1.61
	Spring (March - May)	Summer (June - August)	(September - November) Fall	Winter (December - February)
Unit Maintenance Rating (Fall Only)				
Date of Inspection	4/30/2019 - 4/30/2019			
DWR Inspector	Corey Fujitani			
Accompanied By

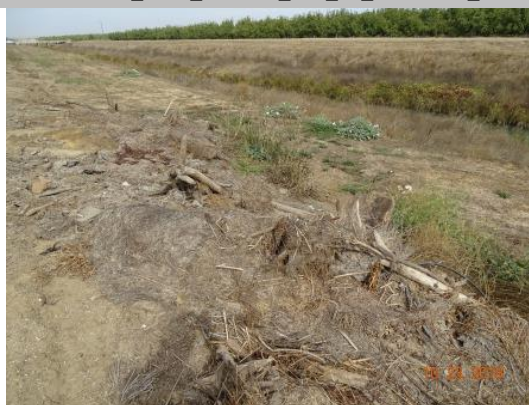
Photo 1 of 1 : SP_2019_NA0013_331_11_20190307_00007.jpg

LM Start	0.02	Rating **	M	Issue No.	11
LM End	0.02	Issue Type +	Ma	Location *	WS
Category	Earthen Levee			GPS Latitude/Longitude	
				Start	End
Item	Encroachments			37.314942 °	37.314942 °
				-120.396394 °	-120.396394 °
DWR ID	DWR_NA0013_01_f_2018_11				
Comment Code					
DE : Debris					
Inspector Comment					
There is garbage on the waterside slope.

Debris and garbage along waterside slope. (Fall 2018)

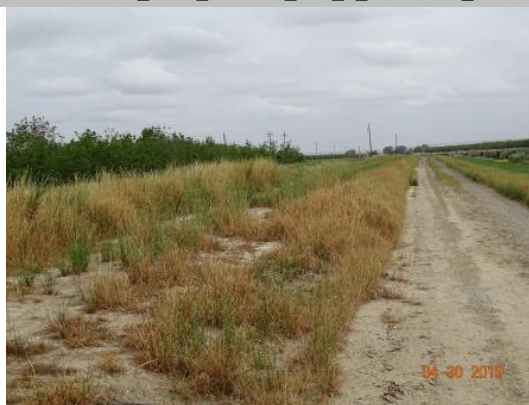
Photo 1 of 1 : SP_2019_NA0013_331_2_20190501_00012.jpg

LM Start	0.04	Rating **	M	Issue No.	2
LM End	1.03	Issue Type +	Ma	Location *	LS
Category	Earthen Levee			GPS Latitude/Longitude	
				Start	End
Item	Vegetation			37.315194 °	37.329597 °
				-120.396389 °	-120.396593 °
DWR ID	DWR_NA0013_01_s_2019_2				
Comment Code					
V1 : Control annual grass and weeds on the levee slopes and easements.					
Inspector Comment

View of landside slope looking upstream. (Spring 2019)

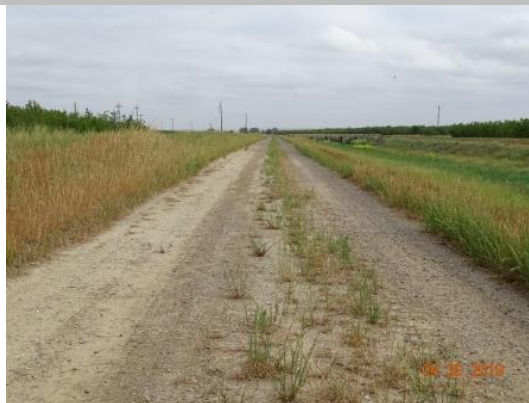
Photo 1 of 1 : SP_2019_NA0013_331_12_20190501_00013.jpg

LM Start	0.04	Rating **	M	Issue No.	12
LM End	0.17	Issue Type +	Ma	Location *	CR
Category	Earthen Levee			GPS Latitude/Longitude	
				Start	End
Item	Vegetation			37.315268 °	37.317130 °
				-120.396387 °	-120.396335 °
DWR ID	DWR_NA0013_01_s_2019_12				
Comment Code					
V9 : Keep the crown roadway free of vegetation.					
Inspector Comment

View of vegetation along levee crown looking upstream. (Spring 2019)

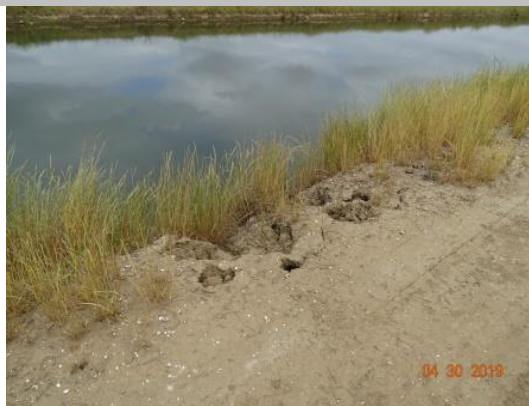
Photo 1 of 1 : SP_2019_NA0013_331_14_20190515_00019.jpg

LM Start	0.75	Rating **	A/W	Issue No.	14
LM End	0.75	Issue Type +	Ma	Location *	LS
Category	Earthen Levee			GPS Latitude/Longitude	
				Start	End
Item	Erosion / Bank Caving			37.325485 °	37.325485 °
				-120.396700 °	-120.396700 °
DWR ID	DWR_NA0013_01_s _ 2019_14				
Comment Code					
E1 : Note and monitor erosion site.					
Inspector Comment

View of erosion on landside slope. (Spring 2019)

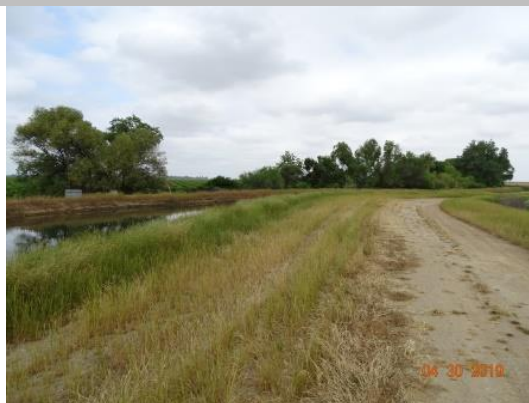
Photo 1 of 1 : SP_2019_NA0013_331_17_20190501_00016.jpg

LM Start	1.25	Rating **	U	Issue No.	17
LM End	1.58	Issue Type +	Ma	Location *	LS
Category	Earthen Levee			GPS Latitude/Longitude	
				Start	End
Item	Vegetation			37.332294 °	37.336724 °
				-120.394732 °	-120.396541 °
DWR ID	DWR_NA0013_01_s_2019_17				
Comment Code					
V1 : Control annual grass and weeds on the levee slopes and easements.					
Inspector Comment

View of landside slope looking upstream. (Spring 2019)

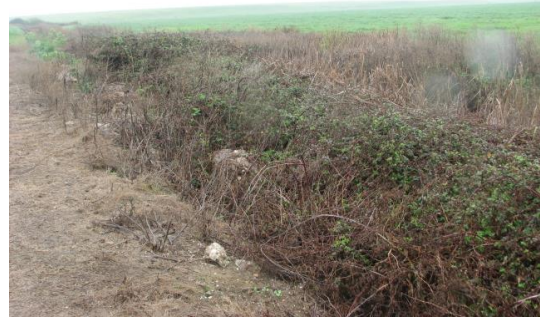
Photo 2 of 2 : SP_2019_NA0013_331_7_20190307_00003.jpg

LM Start	1.57	Rating **	U	Issue No.	7 (cont)	
LM End	1.61	Issue Type +	Ma	Location *	WS	
Category	Earthen Levee			GPS Latitude/Longitude		
				Start		End
Item	Vegetation			37.336576 °		37.337098 °
				-120.396540 °		-120.396528 °
DWR ID	DWR_NA0013_01_s_2018_7					
Comment Code						
V2 : Remove the wild growth other than native grasses from the levee slopes.						
Inspector Comment						
Remove wild roses from waterward slope.

View of wild roses.

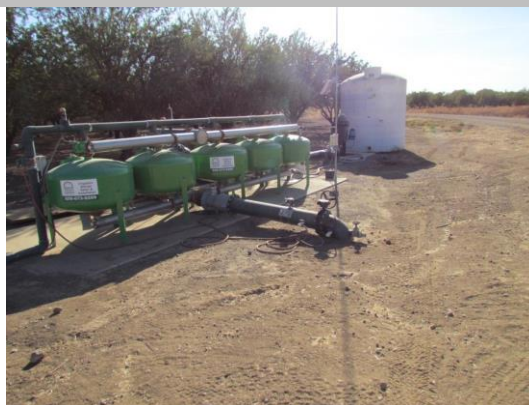
Photo 2 of 3 : SP_2019_NA0013_332_2_20190307_00002.jpg

No Permit for this filtration system and tank on the easement. 2016

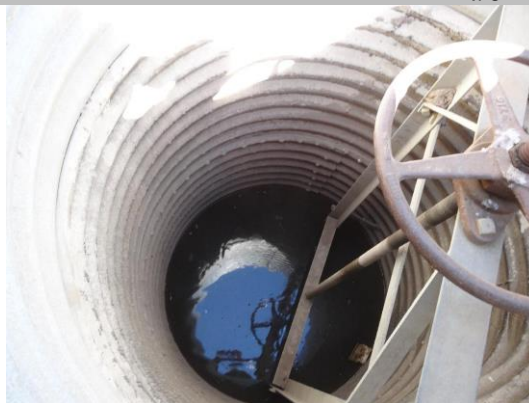
Photo 2 of 3 : UCIP_SP_2019_21263_35760.jpg

WS view: inside view of CMP standpipe with slide gate.

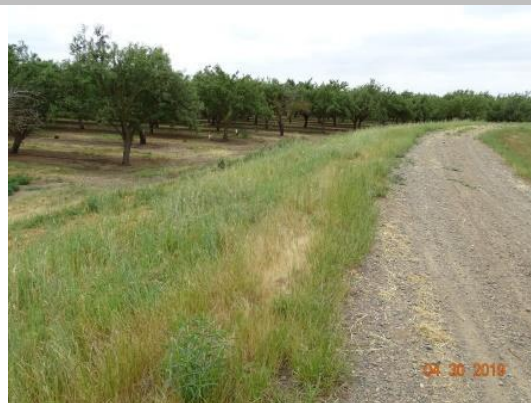
Photo 1 of 2 : SP_2019_NA0013_332_17_20190501_00042.jpg

LM Start	0.41	Rating **	U	Issue No.	17
LM End	0.90	Issue Type +	Ma	Location *	LS
Category	Earthen Levee			GPS Latitude/Longitude	
				Start	End
Item	Vegetation			37.334330 °	37.328360 °
				-120.392537 °	-120.396071 °
DWR ID	DWR_NA0013_02_s_2019_17				
Comment Code					
V1 : Control annual grass and weeds on the levee slopes and easements.					
Inspector Comment

View of landside slope looking downstream. (Spring 2019)

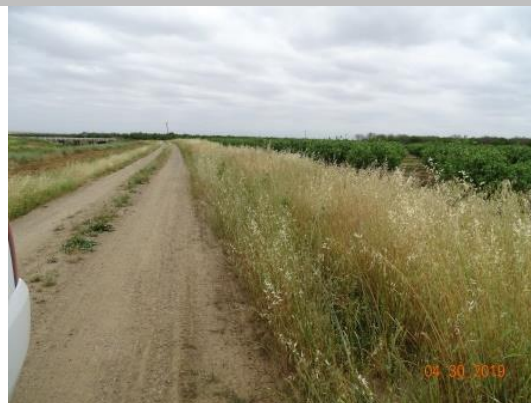
Photo 2 of 2 : SP_2019_NA0013_332_17_20190501_00043.jpg

View of landside slope looking upstream. (Spring 2019)

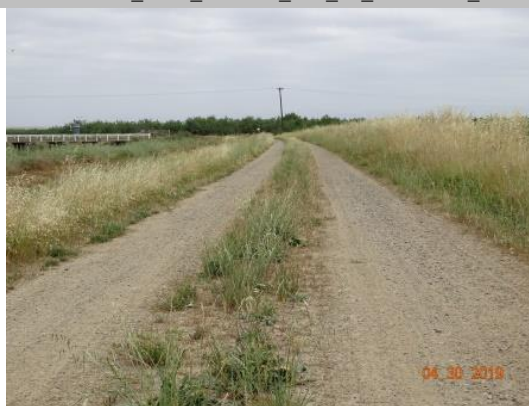
Photo 1 of 1 : SP_2019_NA0013_332_26_20190501_00044.jpg

LM Start	0.62	Rating **	M	Issue No.	26
LM End	0.88	Issue Type +	Ma	Location *	CR
Category	Earthen Levee			GPS Latitude/Longitude	
				Start	End
Item	Vegetation			37.331996 °	37.328702 °
				-120.394121 °	-120.396054 °
DWR ID	DWR_NA0013_02_s_2019_26				
Comment Code					
V1 : Control annual grass and weeds on the levee slopes and easements.					
Inspector Comment

View of vegetation along levee crown. (Spring 2019)

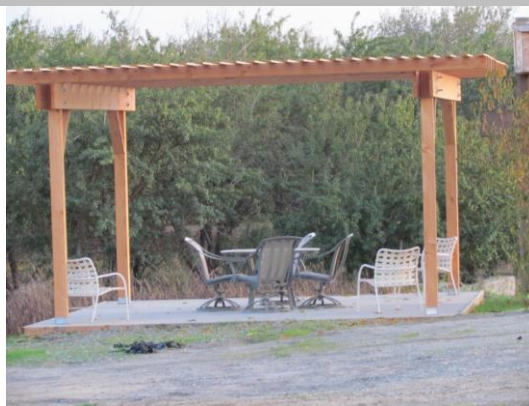
Photo 1 of 4 : SP_2019_NA0013_332_24_20190307_00013.jpg

LM Start	0.88	Rating **	U	Issue No.	24
LM End	0.88	Issue Type +	En	Location *	LS
Category	Earthen Levee			GPS Latitude/Longitude	
				Start	End
Item	Encroachments			37.328567 °	37.328567 °
				-120.396062 °	-120.396062 °
DWR ID	DWR_NA0013_02_s_2014_24				
Comment Code					
TR : Tree or limb					
Inspector Comment					
Three fruit trees with irrigation system, two stock piles of material, and a rock pad are placed on landside toe. Discovered during the fall 2014 inspection was a structure had been installed on the landward levee slope and berm. There are no permits for these encroachments.

Unauthorized encroachment placed on the landside shoulder and berm.

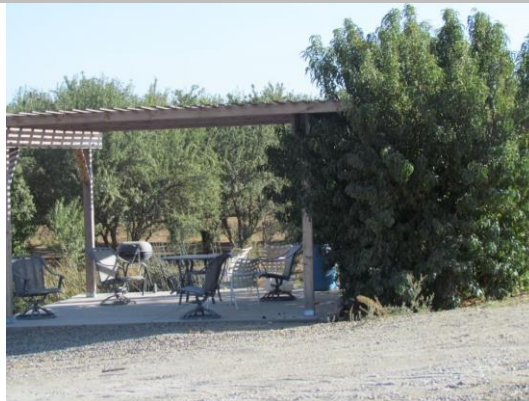
Photo 3 of 4 : SP_2019_NA0013_332_24_20190307_00015.jpg

LM Start	0.88	Rating **	U	Issue No.	24 (cont)
LM End	0.88	Issue Type +	En	Location *	LS
Category	Earthen Levee			GPS Latitude/Longitude	
				Start	End
Item	Encroachments			37.328567 °	37.328567 °
				-120.396062 °	-120.396062 °
DWR ID	DWR_NA0013_02_s_2014_24				
Comment Code					
TR : Tree or limb					
Inspector Comment					
Three fruit trees with irrigation system, two stock piles of material, and a rock pad are placed on landside toe. Discovered during the fall 2014 inspection was a structure had been installed on the landward levee slope and berm. There are no permits for these encroachments.

Unit 2 looking downstream from levee mile 0.88.

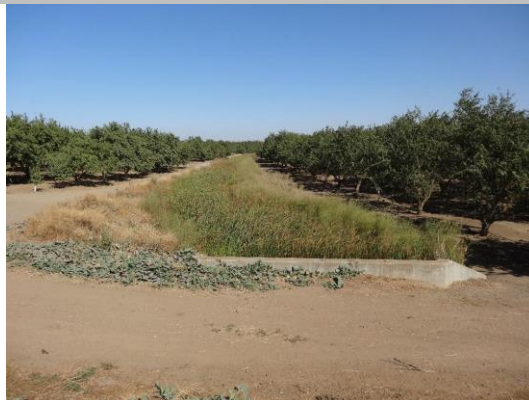
Photo 2 of 3 : UCIP_SP_2019_20965_35291.jpg

LS view: headwall on levee toe. Green vegetation in drainage channel.

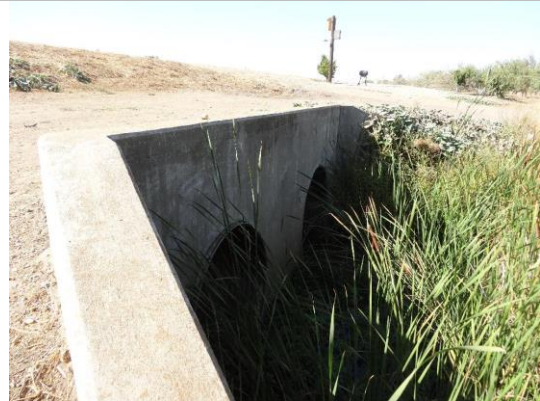
Photo 3 of 3 : UCIP_SP_2019_20965_35290.jpg

Comment Code						
Inspector Comment						
FS_ID:20965						
DS_ID:23056						
EP_NO: N/A						
Repair Type: No Action Needed						
Crossing Status: Found						
UCIP Comments: 09/17/2013 - working during field inspection.-						
vegetation on drainage ditch/channel (DWR UCIP - P. Amatya)						
FIELD_STRUCT_DESC: 1 of 2: 60-inch corrugated metal gravity						
drainage pipe through the levee, 10 feet below the crown. Concrete						
headwall and flap gate on the waterside (WS) berm, 5 feet from the						
levee toe. Concrete headwall on the landside (LS) toe. [Additional						
Reference(s): DWR Levee Log, 2005. USACE San Joaquin O&M						
Manual 607, June 1962, (HLM 0.91)].						
FS Date: 9/17/2013

LS view: two CM pipes and U typed headwall on levee toe. Green vegetation in drainage channel.

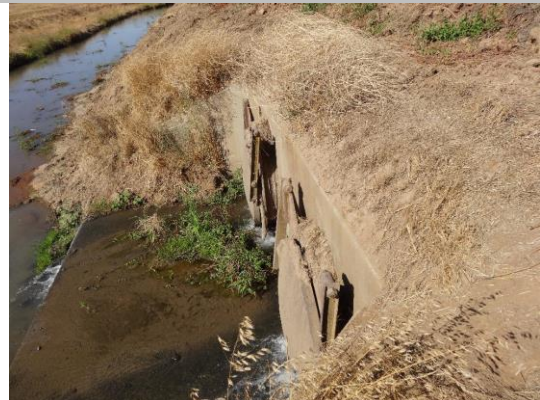
Photo 1 of 3 : UCIP_SP_2019_20983_35302.jpg

LM Start	0.91	Rating **	A/W	Issue No.	36
LM End	0.91	Issue Type +	Ma	Location *	
Category	Supplemental			GPS Latitude/Longitude	
				Start	End
Item	DWR UCIP LMA Responsibility			37.328267 °	37.328267 °
				-120.396084 °	-120.396084 °
DWR ID	23080				
Comment Code					
Inspector Comment					
FS_ID:20983 DS_ID:23080 EP_NO: N/A Repair Type: No Action Needed Crossing Status: Found UCIP Comments: 09/17/2013 It was working during field inspection. Dense vegetation in drainage ditch (DWR UCIP - P. Amatya). FIELD_STRUCT_DESC: 2 of 2: 60-inch corrugated metal gravity drainage pipe through the levee, 10 feet below the crown. Concrete headwall and flap gate on the waterside (WS) berm, 5 feet from the levee toe. Concrete headwall on the landside (LS) toe. [Additional Reference(s): DWR Levee Log, 2005. USACE San Joaquin O&M Manual 607, June 1962, (HLM 0.91)]. FS Date: 9/17/2013

WS view: two CMPs with flap gate, concrete spillway and channel on waterside.

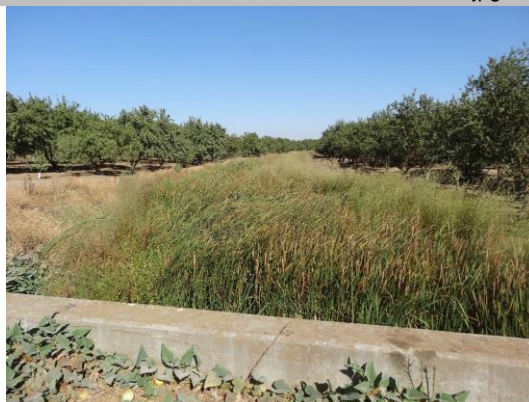
Photo 3 of 3 : UCIP_SP_2019_20983_35300.jpg

LS view: concrete headwall in drainage ditch. Dense vegetation in drainage ditch.

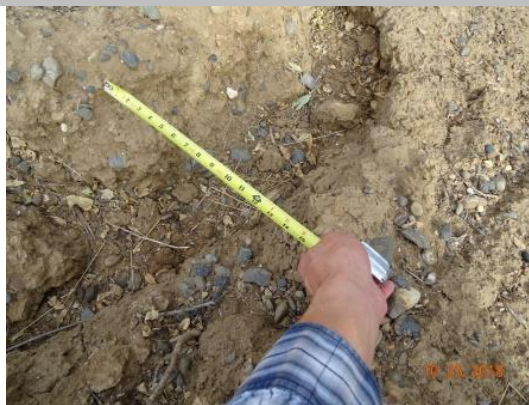
Photo 2 of 2 : SP_2019_NA0013_332_16_20190307_00009.jpg

Measurement across finger erosion. (Fall 2018)

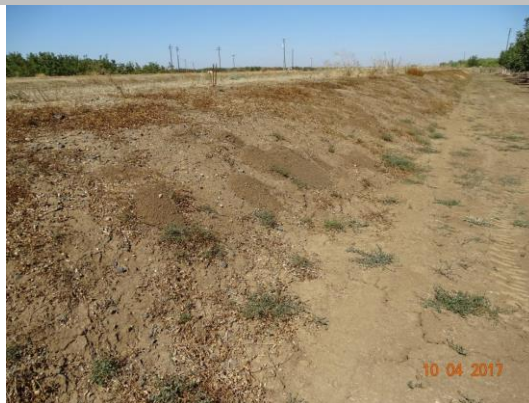
Photo 1 of 1 : SP_2019_NA0013_332_18_20190307_00010.jpg

LM Start	1.30	Rating **	M	Issue No.	18
LM End	1.85	Issue Type +	Ma	Location *	LS
Category	Earthen Levee			GPS Latitude/Longitude	
				Start	End
Item	Animal Control			37.322518 °	37.314652 °
				-120.396042 °	-120.395827 °
DWR ID	DWR_NA0013_02_f_2017_18				
Comment Code					
A3 : No rodents visible, but rodent burrows visible; need to backfill and compact or grout burrows.					
Inspector Comment					
There is rodent activity on the landside slope.

View of rodent activity on the landside slope.

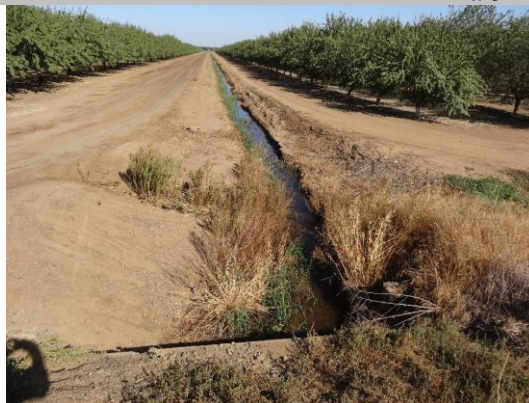
Photo 3 of 3 : UCIP_SP_2019_20984_35303.jpg

LM Start	1.30	Rating **	A/W	Issue No.	37 (cont)	
LM End	1.30	Issue Type +	Ma	Location *		
Category	Supplemental			GPS Latitude/Longitude		
				Start		End
Item	DWR UCIP LMA Responsibility			37.322499 °		37.322499 °
				-120.396045 °		-120.396045 °
DWR ID	23057					
Comment Code						
Inspector Comment						
FS_ID:20984						
DS_ID:23057						
EP_NO: N/A						
Repair Type: No Action Needed						
Crossing Status: Found						
UCIP Comments: 09/17/2013 - working during field inspection. (DWR UCIP - P. Amatya)						
FIELD_STRUCT_DESC: 24-inch corrugated metal gravity drainage pipe through the levee, 10 feet below the crown. Concrete headwall, flap gate, and concrete grouted cobble spillway on the waterside (WS) toe. Concrete headwall on the landside (LS) toe. [Additional Reference(s): DWR Levee Log, 2005. USACE San Joaquin O&M Manual 607, June 1962, (HLM 1.32)].						
FS Date: 9/17/2013

LS view: concrete headwall on levee toe and drainage ditch.

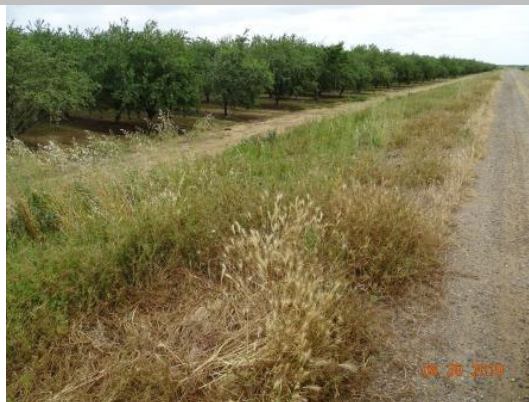
Photo 1 of 1 : SP_2019_NA0013_332_28_20190501_00046.jpg

LM Start	1.32	Rating **	U	Issue No.	28
LM End	1.66	Issue Type +	Ma	Location *	LS
Category	Earthen Levee			GPS Latitude/Longitude	
				Start	End
Item	Vegetation			37.322298 °	37.317361 °
				-120.396035 °	-120.395748 °
DWR ID	DWR_NA0013_02_s_2019_28				
Comment Code					
V1 : Control annual grass and weeds on the levee slopes and easements.					
Inspector Comment

View of vegetation along landside slope looking downstream. (Spring 2019)

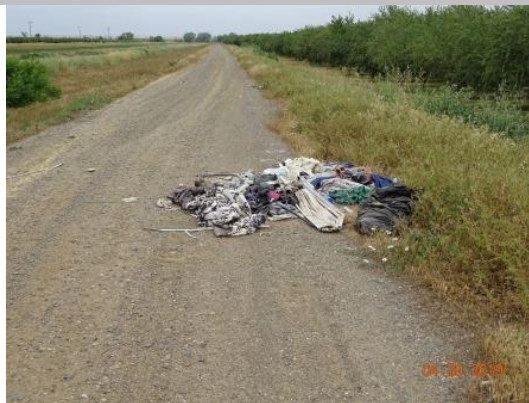
Photo 1 of 1 : SP_2019_NA0013_332_29_20190501_00047.jpg

LM Start	1.52	Rating **	M	Issue No.	29
LM End	1.52	Issue Type +	Ma	Location *	CR
Category	Earthen Levee			GPS Latitude/Longitude	
				Start	End
Item	Encroachments			37.319367 °	37.319367 °
				-120.396030 °	-120.396030 °
DWR ID	DWR_NA0013_02_s_2019_29				
Comment Code					
GA : Garbage					
Inspector Comment					
There is trash left on the waterside of the levee crown.

Trash left on waterside of levee crown. (Spring 2019)

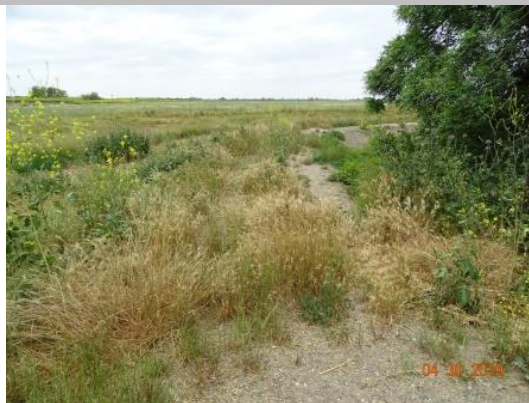
Photo 3 of 3 : SP_2019_NA0013_333_12_20190503_00031.jpg

LM Start	0.00	Rating **	U	Issue No.	12 (cont)
LM End	1.26	Issue Type +	Ma	Location *	LS

View of landside slope looking downstream at the Mission Ave access point. (Spring 2019)

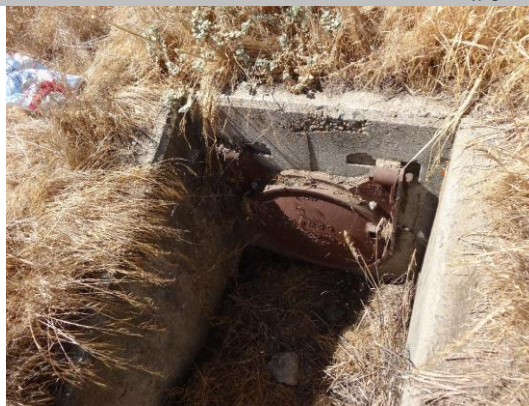
Photo 1 of 3 : UCIP_SP_2019_41815_35533.jpg

Comment Code						
Inspector Comment						
FS_ID:41815						
DS_ID:23060						
EP_NO: N/A						
Repair Type: Non-Urgent						
Crossing Status: Found						
UCIP Comments: 09/17/2013 - more than a half of inet pipe burried on						
LS. - needs vegetation cleaning on both sides.- inlet needs silt						
removed and cleaning. (DWR UCIP - P. Amatya)						
FIELD_STRUCT_DESC: 24-inch corrugated metal gravity drainage pipe						
through the levee, 6 feet below the crown. Concrete headwall, flap gate,						
and concrete grouted cobble spillway on the waterside (WS) toe.						
Concrete headwall on the landside (LS) toe. [Additional Reference(s):						
DWR Levee Log, 2005. USACE San Joaquin O&M Manual 607, June						
1962, (HLM 0.18)].						
FS Date: 9/17/2013

WS view: U typed concrete headwall, CM pipe, and flap gate.

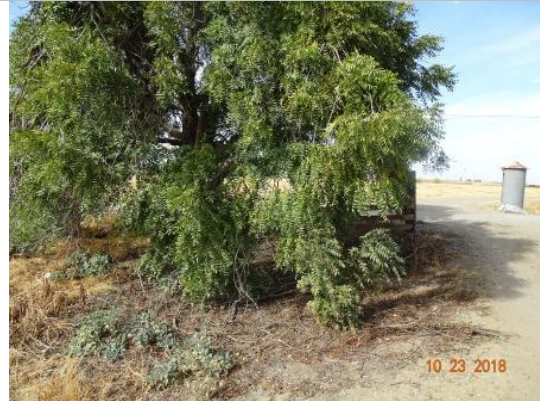
Photo 1 of 1 : SP_2019_NA0013_333_16_20190307_00005.jpg

LM Start	1.25	Rating **	M	Issue No.	16
LM End	1.25	Issue Type +	Ma	Location *	LS
Category	Earthen Levee			GPS Latitude/Longitude	
				Start	End
Item	Trim / Thin Trees			37.272801 °	37.272801 °
				-120.280304 °	-120.280304 °
DWR ID	DWR_NA0013_03_f_2018_16				
Comment Code					
T1 : Trim trees to at least five feet above ground level.					
Inspector Comment

tree on landside slope. (Fall 2018)

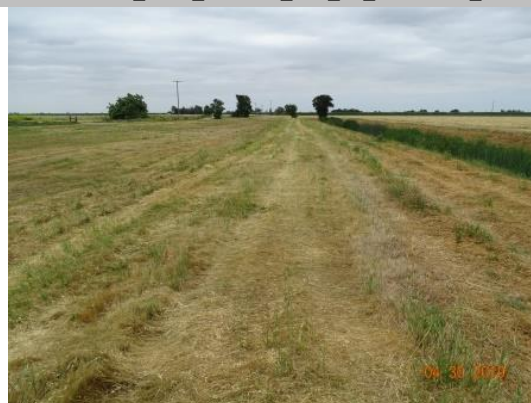
Photo 1 of 1 : SP_2019_NA0013_334_22_20190503_00034.jpg

LM Start	0.01	Rating **	M	Issue No.	22
LM End	0.14	Issue Type +	Ma	Location *	CR
Category	Earthen Levee			GPS Latitude/Longitude	
				Start	End
Item	Vegetation			37.273313 °	37.272995 °
				-120.277840 °	-120.279976 °
DWR ID	DWR_NA0013_04_s _ 2019_22				
Comment Code					
V9 : Keep the crown roadway free of vegetation.					
Inspector Comment

View of levee crown looking downstream. (Spring 2019)

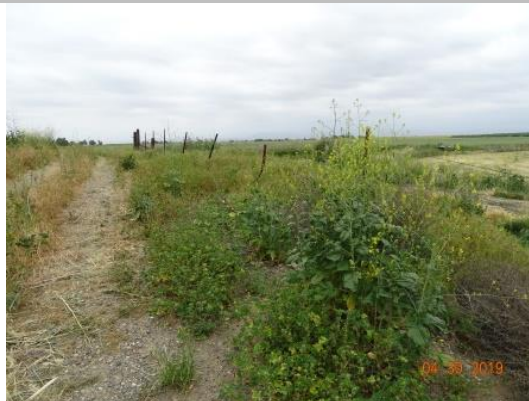
Photo 2 of 2 : SP_2019_NA0013_334_23_20190503_00036.jpg

LM Start	0.15	Rating **	U	Issue No.	23 (cont)	
LM End	1.03	Issue Type +	Ma	Location *	LS	
Category	Earthen Levee			GPS Latitude/Longitude		
				Start		End
Item	Vegetation			37.272888 °		37.262809 °
				-120.279992 °		-120.287890 °
DWR ID	DWR_NA0013_04_s_2019_23					
Comment Code						
V1 : Control annual grass and weeds on the levee slopes and easements.						
Inspector Comment

View of landside slope looking upstream. (Spring 2019)

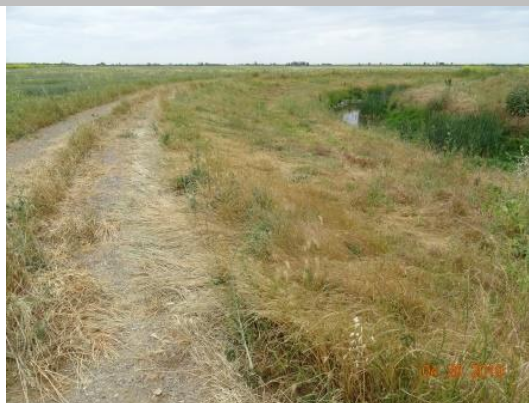
Photo 1 of 2 : SP_2019_NA0013_334_24_20190503_00037.jpg

LM Start	0.15	Rating **	U	Issue No.	24
LM End	1.03	Issue Type +	Ma	Location *	WS
Category	Earthen Levee			GPS Latitude/Longitude	
				Start	End
Item	Vegetation			37.272887 °	37.262809 °
				-120.279997 °	-120.287890 °
DWR ID	DWR_NA0013_04_s_2019_24				
Comment Code					
V1 : Control annual grass and weeds on the levee slopes and easements.					
Inspector Comment

View of waterside slope looking downstream. (Spring 2019)

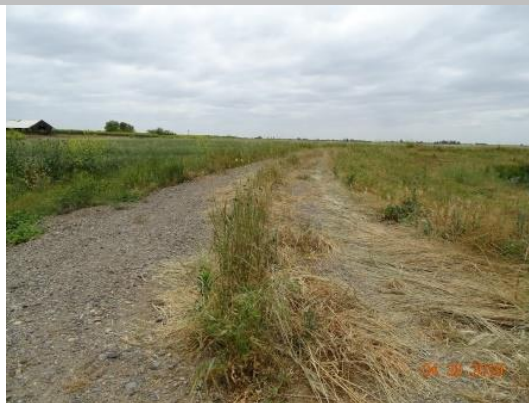
Photo 1 of 2 : SP_2019_NA0013_334_25_20190503_00039.jpg

LM Start	0.15	Rating **	U	Issue No.	25
LM End	1.03	Issue Type +	Ma	Location *	CR
Category	Earthen Levee			GPS Latitude/Longitude	
				Start	End
Item	Vegetation			37.272885 °	37.262808 °
				-120.280000 °	-120.287890 °
DWR ID	DWR_NA0013_04_s_2019_25				
Comment Code					
V9 : Keep the crown roadway free of vegetation.					
Inspector Comment

View of vegetation on levee crown looking downstream. (Spring 2019)

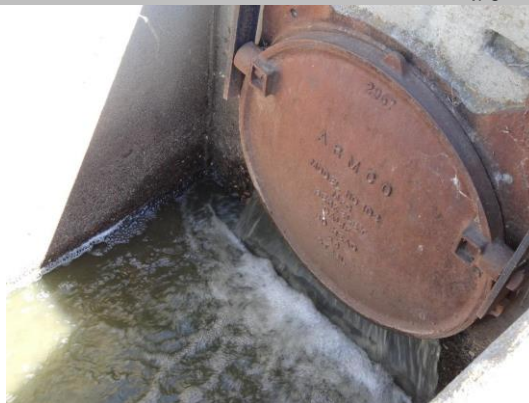
Photo 3 of 3 : UCIP_SP_2019_21127_35655.jpg

Comment Code						
Inspector Comment						
FS_ID:21127						
DS_ID:23074						
EP_NO: N/A						
Repair Type: No Action Needed						
Crossing Status: Found						
UCIP Comments: 09/17/2013 - concrete spillway on waterside.-						
drainage was working during field survey (DWR UCIP - P. Amatya).						
FIELD_STRUCT_DESC: 24-inch corrugated metal gravity drainage pipe						
through the levee, 8 feet below the crown. Concrete headwall, flap gate,						
and concrete grouted cobble spillway on the waterside (WS) toe.						
Concrete headwall on the landside (LS) toe. [Additional Reference(s):						
DWR Levee Log, 2005. USACE San Joaquin O&M Manual 607, June						
1962, (HLM 1.02)].						
FS Date: 9/17/2013

WS view: U typed concrete headwall, CM pipe, and flap gate. Drainage was working during survey.

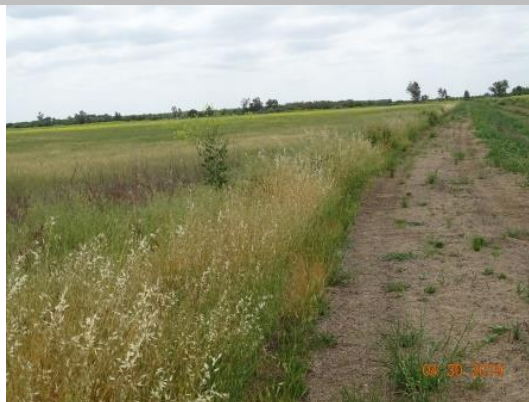
Photo 1 of 1 : SP_2019_NA0013_334_12_20190503_00041.jpg

LM Start	1.07	Rating **	U	Issue No.	12
LM End	1.41	Issue Type +	Ma	Location *	LS
Category	Earthen Levee			GPS Latitude/Longitude	
				Start	End
Item	Vegetation			37.262357 °	37.257476 °
				-120.288236 °	-120.288147 °
DWR ID	DWR_NA0013_04_s_2019_12				
Comment Code					
V1 : Control annual grass and weeds on the levee slopes and easements.					
Inspector Comment

View of landside slope looking downstream. (Spring 2019)
